The provision of new sign structures can prove more economic than re-use of existing ones

The Incident

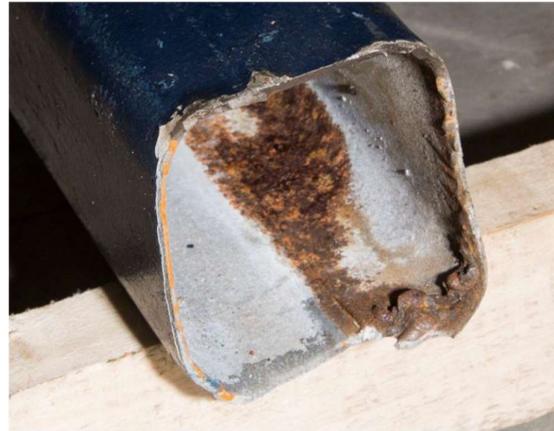
The incident occurred during a named storm force event. During the event, a gust wind speed was measured at 68 mph (30.4 m/s) some 17 miles away from the sign. The exact wind speed at the sign location is not known. On the morning of the incident, a pedestrian was walking past the sign when the support post broke apart, striking and fatally injuring the passer-by.

A metallurgical examination was carried out on the support post which had fractured approximately 2,600mm above ground level at one of the transverse weld sections. The transverse butt weld at the fracture location exhibited regions of incomplete weld penetration through the post wall and internal corrosion. A fatigue crack was present in the full-length U-channel adjacent to the butt weld and had initiated at the unfused edge of the transversely welded channel. The unfused areas would have raised the local stresses in the post, reducing resistance to fatigue crack initiation, propagation and an increased susceptibility to failure.

The larger sign increased the forces acting upon the post and were a contributory factor in the post failure, but in fact, calculations indicate that the support post would not have structurally failed with the larger sign had the support been free from defects and corrosion.

The Association recommends that installers clearly set out the need for a complete assessment of the existing structure from a safety perspective. They should offer to supply a price for two options. One quoted option should be the cost for the installer to carry out a full site, structural and ground investigation; with a second option for designing and building a complete new structure (with a price for the removal of the old). It is likely that, since at least some structures fully investigated would prove unsuitable, the latter would in most cases be cheaper overall. This will discourage the re-use of old sign supports, which as this case demonstrated, may prove not to be sufficiently safe and a false economy.
